**CONSOLIDATION AND ADHESIVE REPAIR OF VOLCANIC TUFF  
CASE STUDY: CONSERVATION OF VOLCANIC TUFF AT THE OLD  
STONE CHURCH OF MISSION SAN JUAN CAPISTRANO,  
SAN JUAN CAPISTRANO, CALIFORNIA**

Evin Hewett Erder

A THESIS

The Graduate Program in Historic Preservation

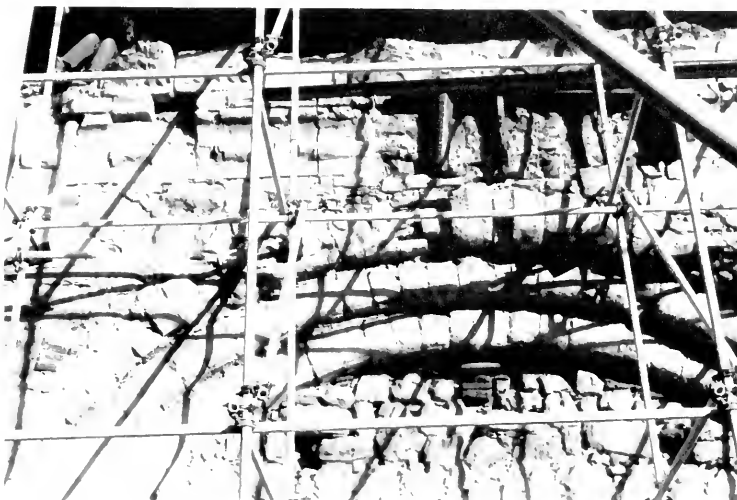
Fig. 14. East wall of nave. Disaggregated and cracking tuff blocks in cornice.

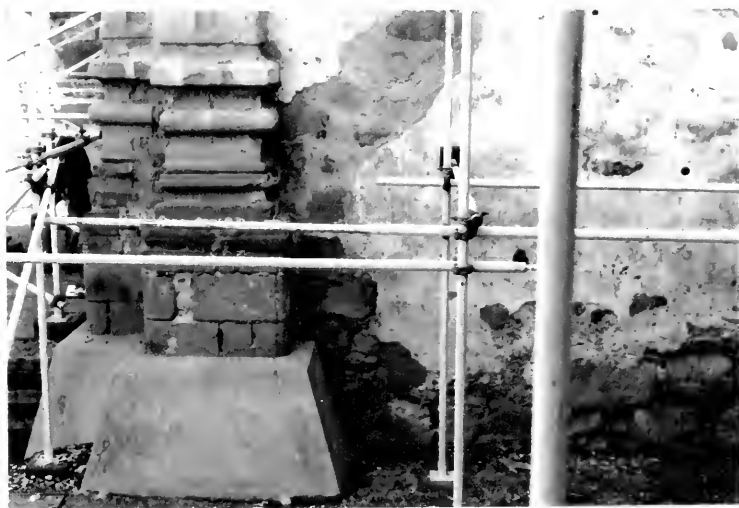
Fig. 15. North wall of east transept. Cementitious mortar repairs on stones, around edges of plaster, and as encasement of pilaster base at north wall of east transept.

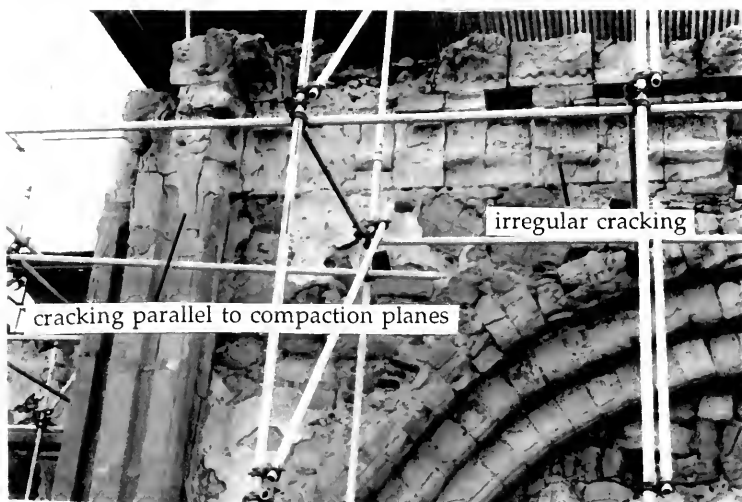
(3) **microcracking** (> 1 mm.) is usually localized and confined to a single block. This condition predominates in volcanic tuff blocks and yellow sandstones in irregular patterns (i.e., map cracking) and is normally caused by inherent weaknesses in the stone, moisture penetration, surface hardening, and internal geo-physical stresses.

Fig. 18. Cracking of volcanic tuff blocks in pilaster and cornice in east wall of nave.

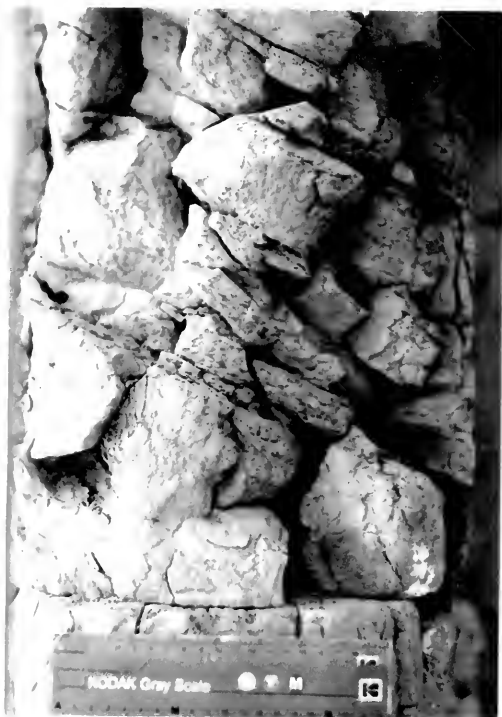
Fig. 19. Irregular and diagonal cracking of volcanic tuff blocks at intersection of west wall of nave and transept (Photo: Anne Brackin).

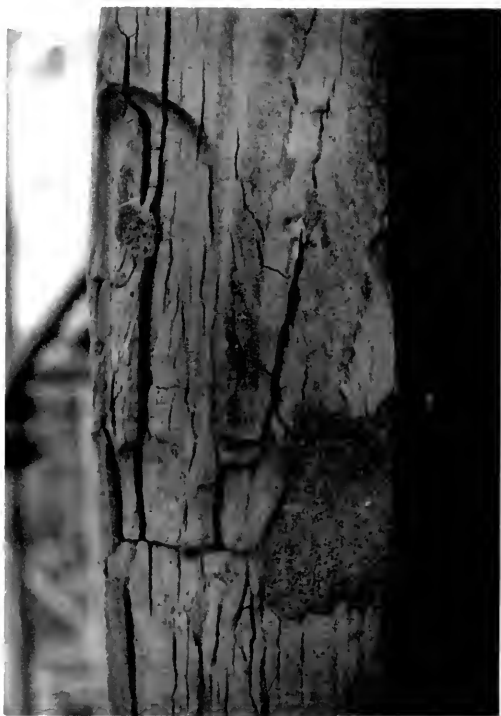
Fig. 20. Vertical cracking along bedding planes of tuff at intersection of east wall of nave and transept. Cementitious mortar repair in areas of loss (Photo: Anne Brackin).

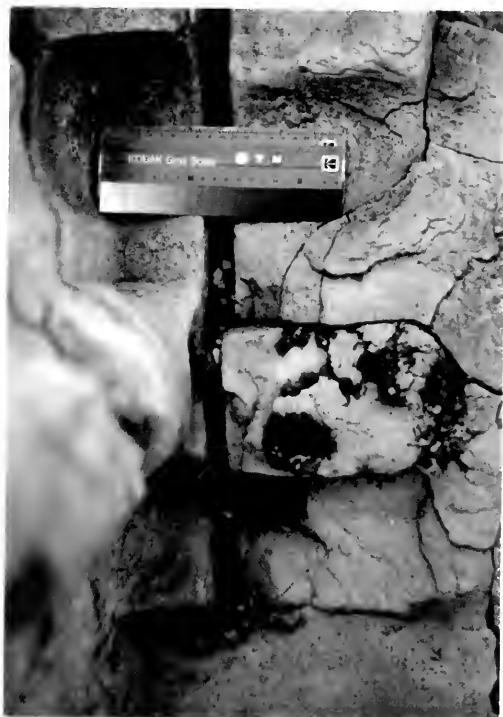
The presence of algae, lichens, and other microflora and higher plant growth may be found either in cracks, open joints, or on the surface of stones in areas of high moisture. Vegetation and plant roots predominate in open joints in volcanic tuff blocks in the upper tier of the cornice in sheltered areas on the west and south walls. A black growth, probably a combination of algae and lichen, predominates in the volcanic tuff in isolated areas exposed to adequate light and moisture at the intersection of walls and on blocks in the lower tiers of cornices.

Fig. 21. Biological growth on tuff at intersection of west wall of nave and transept adjacent to open joints and cracks (Photo: Anne Brackin).

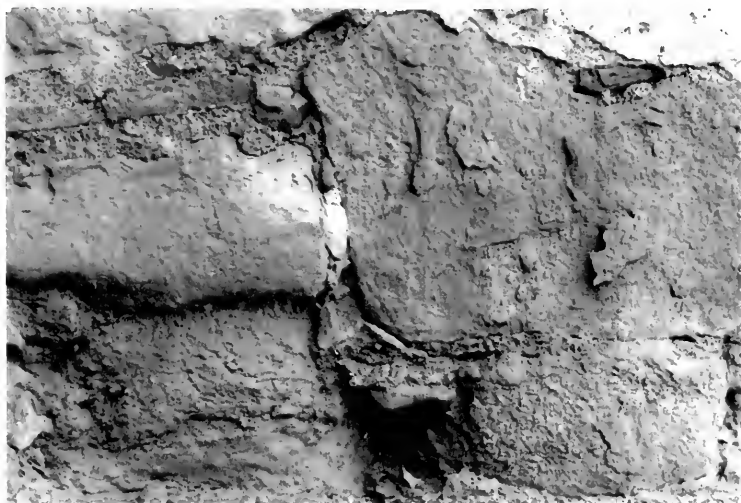
Active detachment and loss of small, thin flakes of stone not necessarily in association with bedding planes or stone orientation. This condition occurs in the green and yellow sandstone and volcanic tuff blocks with their preferred direction of compaction or bedding planes parallel, perpendicular, or diagonal to the surface of the wall. This condition is most severe in the first two courses of stones above the base of walls, in areas exposed to moisture and sunlight, and appears to be related to soluble salt formation.

Fig. 22. Flaking of green sandstones above base of wall at north wall of east transept.

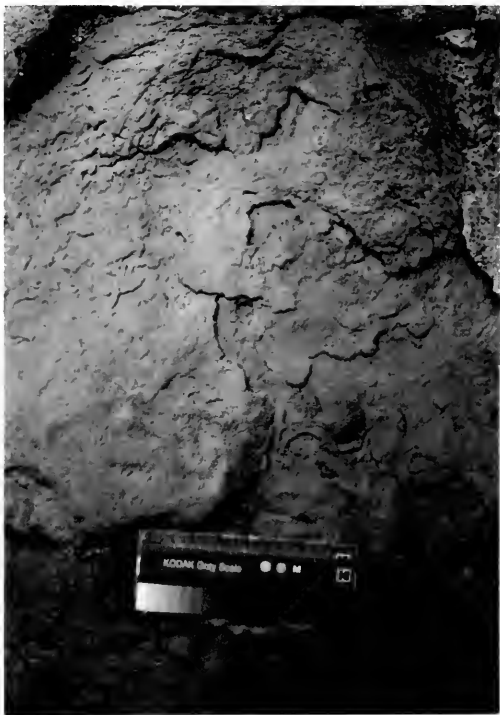
Localized uneven loss of layers of stone, often of uniform thickness, which occurs in a step-like pattern creating contoured depressions associated with bedding and stone orientation. This condition occurs in volcanic tuff blocks and yellow sandstones with distinct bedding planes parallel, perpendicular, or diagonal to the surface of the wall, in the pilaster capitals and shafts, upper and lower tiers of the cornices, and the arches on the west and east walls of the nave. The condition is most severe in unprotected blocks exposed to light and moisture.

Fig. 23. Contour scaling and flaking of green sandstone 3' above grade at east wall of east transept (Photo: Anne Brackin).

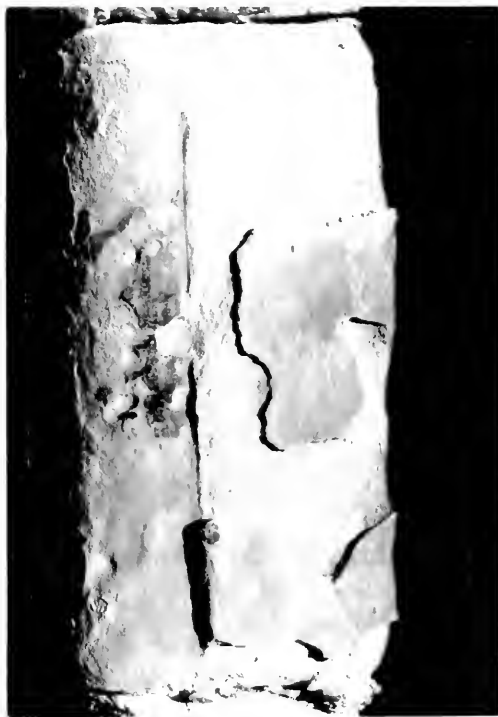
This constitutes detachment and loss of one or more surface layers of stone of uniform thickness and parallel to each other in association with bedding and stone orientation. The condition predominates in green and yellow sandstones with bedding parallel to the surface of the wall at the bases of walls and pilasters. It is normally caused by the penetration and capillary rise of ground water, and the formation of soluble salts, and wet-dry cycling.

Fig. 24. Exfoliation of yellow sandstone at base of arch in east wall of nave (Photo: Anne Brackin)

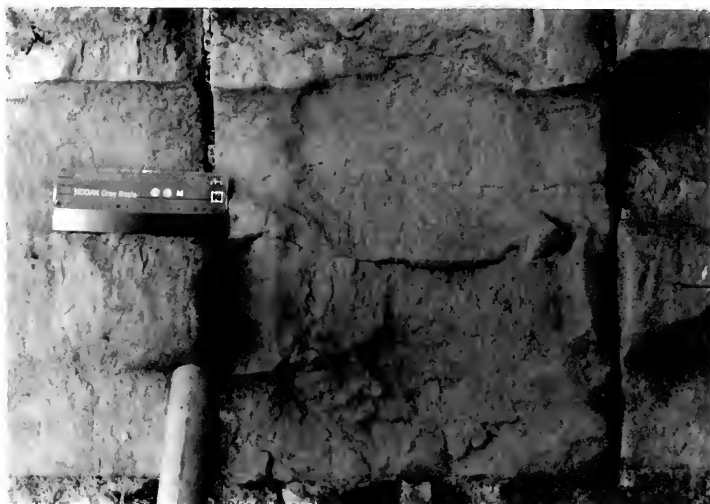
Defined as partial or complete loss of stone often in association with exfoliation, disaggregation and previous repairs. This condition predominates in volcanic tuff and sandstone blocks with narrow to wide cracking ( 1 mm. to 10 cm.) or contour scaling. In addition, losses occur in unprotected areas exposed to the weather where disaggregation of the stones leads to surface erosion. All loss results in an incompleteness of form or carved decoration.

Fig. 25. Cracking and partial loss of tuff at cornice level in west wall of nave (Photo: Anne Brackin).

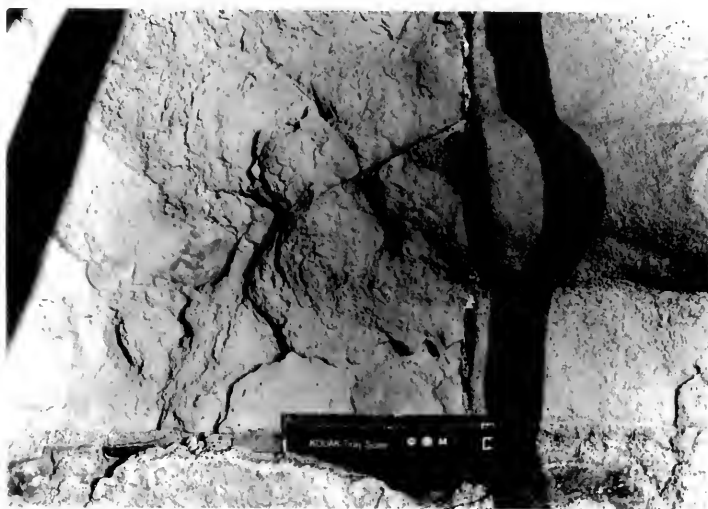
Planar or linear discontinuities are defined by (1) uninterrupted deformation or distinct fragmentation in association with cracking or loss within a single block, or by (2) misalignment of adjoining elements. This condition predominates in volcanic tuff blocks in the cornices, pilasters, and around the doorways in the apse and is normally caused by continuous cracking and gross structural movement.

Fig. 26. Cracking and displacement of tuff at cornice level at east wall of apse (Photo: Anne Brackin).

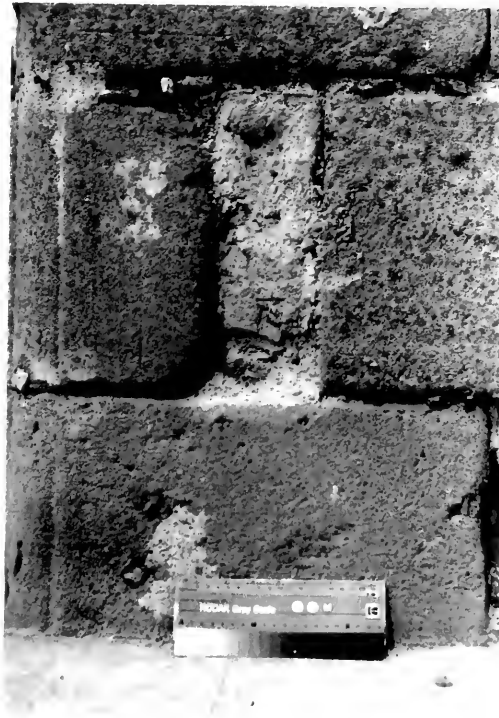
Active detachment of grains resulting in a rough, granular appearance, and overall friability of the stone surface. The condition predominates in unprotected volcanic tuff blocks at the cornices and pilaster capitals and in sandstone blocks at the bases of walls. The causes are usually moisture and salt penetration, and wet-dry cycling.

Fig. 27. Disaggregation of tuff at pilaster base at the intersection of the apse and east arm of the transept (Photo: Anne Brackin).

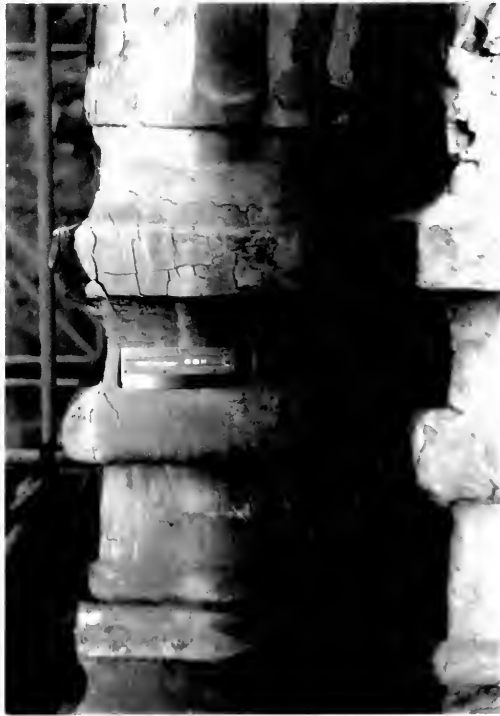
Complete or partial loss, cracking, or separation of mortar within the masonry joints. This condition predominates in high exposure and moisture areas in the tuff at the cornices, pilaster capitals and bases, and the sandstone blocks at pilaster bases and arches on west and east walls of the nave. Open or defective joints are normally caused by: moisture penetration and differential expansion and contraction or movement of the mortar within the joints and adjoining stones, efflorescence, and biological growth.

Fig. 28. Open and defective joints at base of pilaster at the intersection of the east transept and east wall of nave (Photo: Anne Brackin).

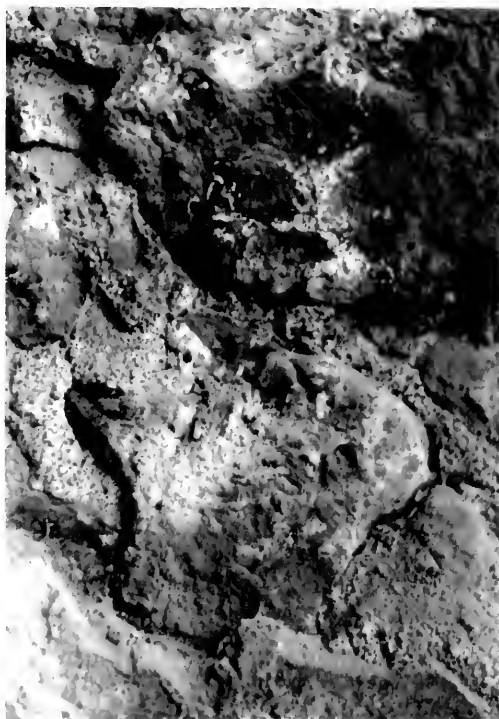
White crystalline surface deposits composed of water-soluble salts, often found in areas of water penetration. This condition predominates in yellow and green sandstone blocks located at the bases of walls and pilasters 1'-2' above grade. The cause is normally the penetration and capillary rise of ground water and associated soluble salts through the stone. As the stone dries, these salts crystallize on or below the surface as cryptofluorescence and present a significant cause of deterioration in sandstone blocks above grade level. The rapid wetting and drying in these areas results in severe exfoliation, contour scaling, and flaking due to the internal disruptive pressures of the crystallized salts in the stone pores.

Fig. 29. Efflorescence on sandstone 1.5' (46 cm.) above grade at northeast wall of apse.

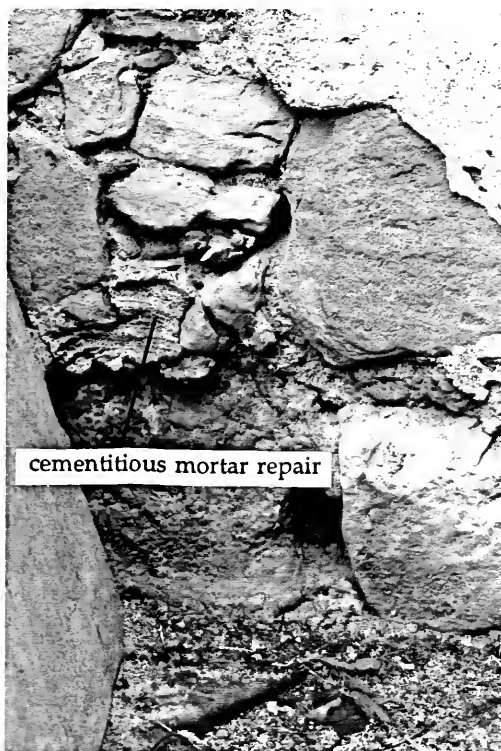
Subsequent alterations made for structural, aesthetic or functional reasons, such as mortar patching and stone dutchmen, cracking, flaking, contour scaling and exfoliation. Repairs on the interior of the Old Stone Church occur primarily in volcanic tuff blocks at the cornices, pilaster capitals, shafts and bases, and the doorways and sandstone arches in the apse. Repointing of these mortar joints occurs throughout the interior of the church. The specific locations of the repointing campaigns, however, have not been recorded in previous documentation conditions. The stone behind and around mortar repairs show signs of efflorescence and disaggregation. Some significant losses of stone occur, especially adjacent to cementitious repairs, suggesting a relationship between the inappropriateness of the repair and the condition.

Fig. 30. Cementitious mortar repairs and associated efflorescence above grade at the intersection of the apse and east arm of the transept.
